**UNDERWATER FACILITIES
INSPECTIONS
AND
ASSESSMENTS
AT**

**EXPLOSIVE HANDLING WHARF 1
STRATEGIC WEAPONS
FACILITY PACIFIC
BANGOR, WASHINGTON**

FPO-1-82 (01)

JUNE, 1981

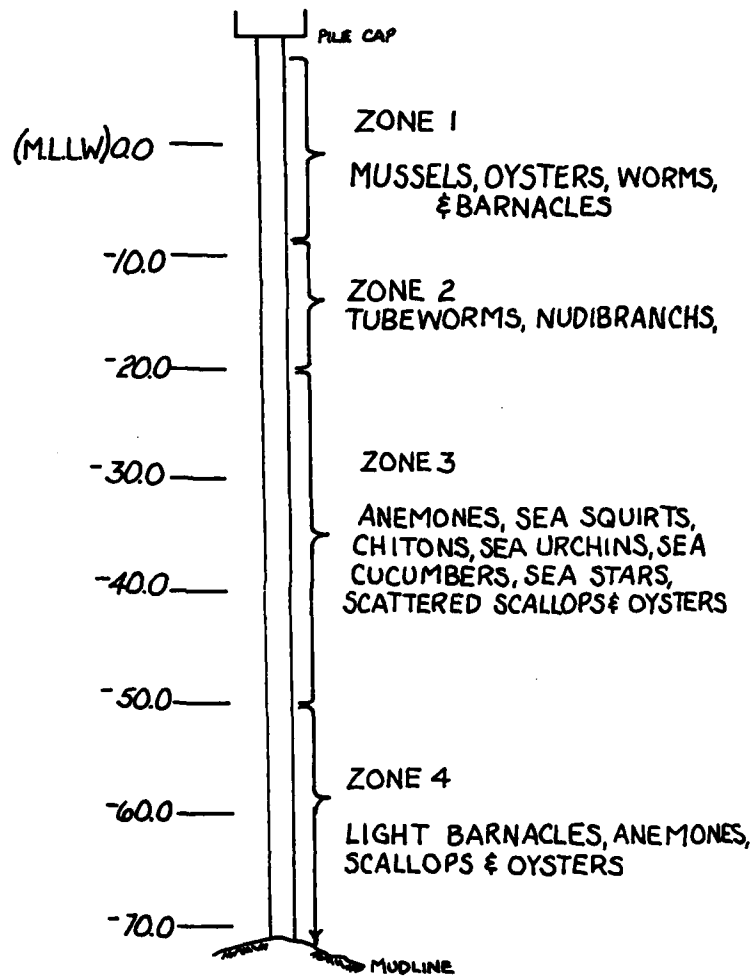
FIG. 4 MARINE GROWTH PROFILE - CONCRETE PILES

It should be recognized that there is considerable overlapping of these zones and that they are not distinguishable on all of the pilings. Figure 4 shows the approximate ranges of these types of marine growth for the concrete piles.

Zone 1 encompasses the splash zone, the intertidal zone, and the upper subtidal zone. In this zone the thickest growth is encountered and the piles are nearly always 100 percent covered. Growth in the splash zone, where there is only intermittent wetting, consists primarily of a thin covering of barnacles and scattered mussels. The intertidal zone, immediately below the splash zone, contains approximately ten vertical feet of heavy mussel, oyster and barnacle growth, frequently in excess of two inches thick (see photographs 1 and 2).

Zone 3 represents an area of heavy anemone growth frequently occurring in lengths up to two feet. The majority of the anemones are plumose anemones and were white, orange, or brown in color. In addition to anemones there are scattered appearances of sea urchins, sea cucumbers, calcareous tube worms, oysters, nudibranchs, tunicates, sea squirts, chitons, sea stars, and scallops (see photograph 4).

In Zone 4 marine growth gradually diminishes leaving only a thick covering of barnacles approximately one-half inch thick toward the mudline. Interspersed among the barnacles are very small scallops and oysters along with occasional concentrations of calcareous tube worms, sea squirts, and small anemones (see photograph 5).
